SUBSIDENCE MANAGEMENT AT NEW MINERAL CITY MINE, FORT DODGE, IOWA

Joseph Crawford, United States Gypsum Company, Chicago, IL
Jon Blazic, United States Gypsum Company, Fort Dodge, IA
Matt Benzie, United States Gypsum Company, Fort Dodge, IA
Kelvin Price, United States Gypsum Company, Plasterco, VA

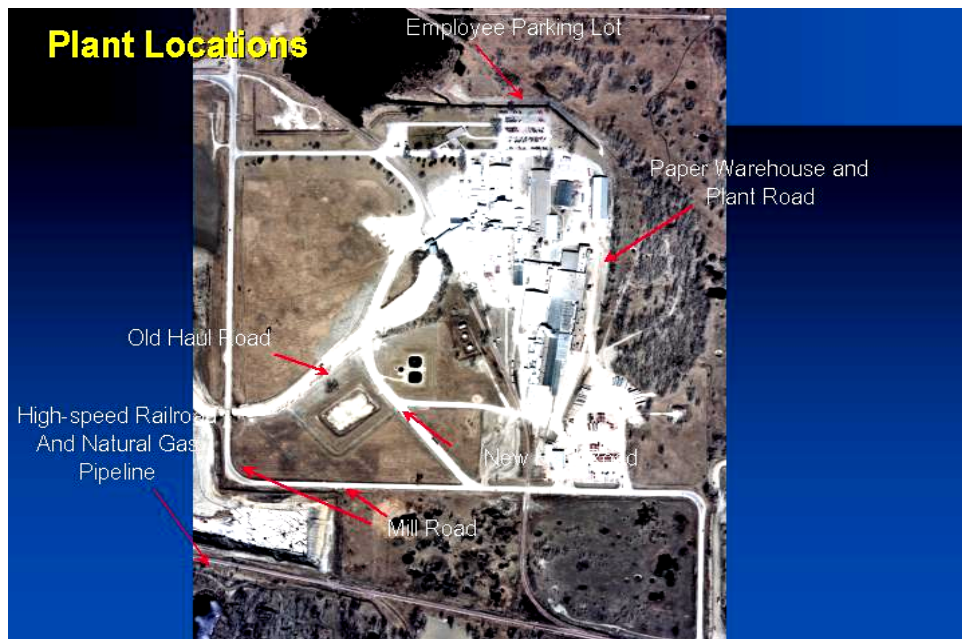
Figure 1. *Present-day USG Fort Dodge, IA manufacturing facility and transportation infrastructure. New Mineral City Mine underlies much of photo area.*

U.S. Gypsum's New Mineral City Mine is located on the outskirts of the City of Fort Dodge, Webster County, Iowa (Figure 1). The underground mine workings have been inactive since 1927, and operated for about 30 years concurrent with several other competitive underground mining operations in the Fort Dodge vicinity. Historical mine development consisted of drilling and blasting methods in a room-and-pillar configuration. The mining seam is situated 60-70 ft below the regional ground surface. The mined voids are partially flooded.

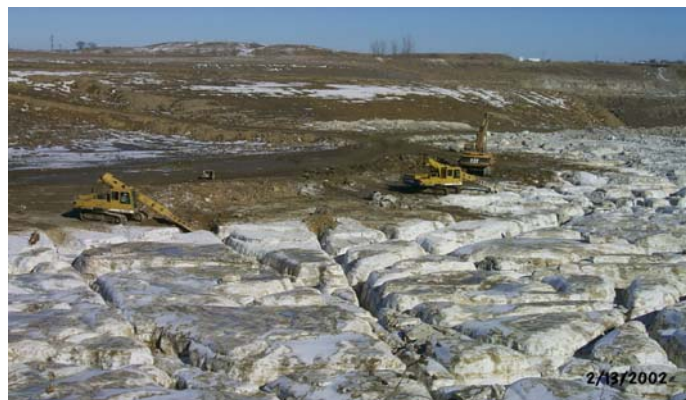
Figure 3. Linear dissolution features at top gypsum, USG Flintkote quarry.

The Fort Dodge gypsum deposits have been affected by natural karst processes to the degree that dissolution enlarged joints impact current quarrying practices (Figure 3). It was through studying these types of features that USG personnel gained insight toward an effective approach for selective remediation in evaporite systems.

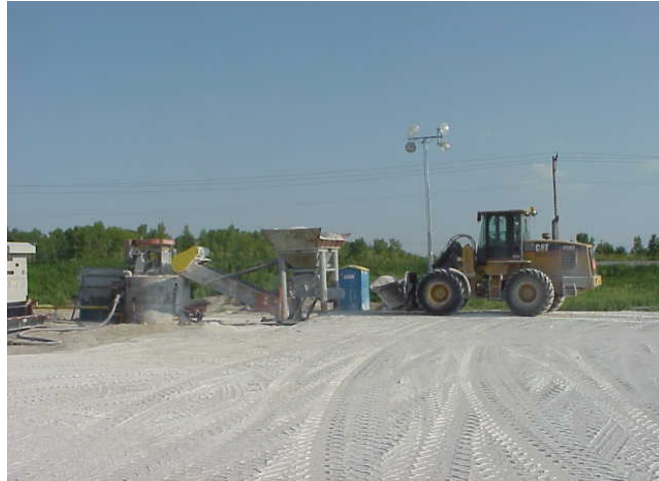
Figure 10. *Backfill stowing machine set-up; hopper, conveyor, mixing tank. Portable lights for round-the-clock operations.*

Two USG-built stowing units were used for mixing and pumping the slurry (Figure 10). A unit consists of a hopper with vibrating discharge, a belt conveyor, a mixing tank with agitator, and a centrifugal suction pump. Front loaders fed the manufactured sand (3/8-inch minus) into the hoppers. Pipelines consisted of HDPE and steel pipe. The mixing tank volume is about 2,250 gal capacity. The daily injection rate capacities of the stowing machines were to be determined during the course of the project through experience with maintenance and logistical issues.

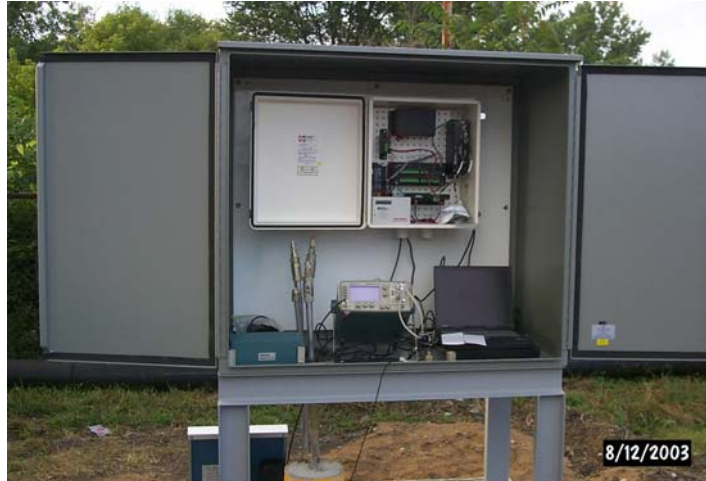
Figure 11. *Automated data acquisition system installation at employee parking lot.*

The TDR system emplaced at the undermined employee parking lot consists of 1,940-ft of 7/8-in cable grouted in trenches that loop around and cross the parking lot (Figure 5). The five separate cable installations were sited based on geological considerations obtained from drilling, underground observations and historical mine maps. The parking lot system was designed to be a semi-permanent installation until USG could either move the parking lot or determine another cost effective method of remediation. The installations are monitored continuously using a centralized, automated cable-interrogation system with autodialer call-out alarm capabilities (Figure 11).
